**Visual evidence of the massive problems associated with total mis-management of the Murray Darling Basin by consecutive Federal, State and Local Governments.**

Long Island Marina – Murray Bridge – South Australia

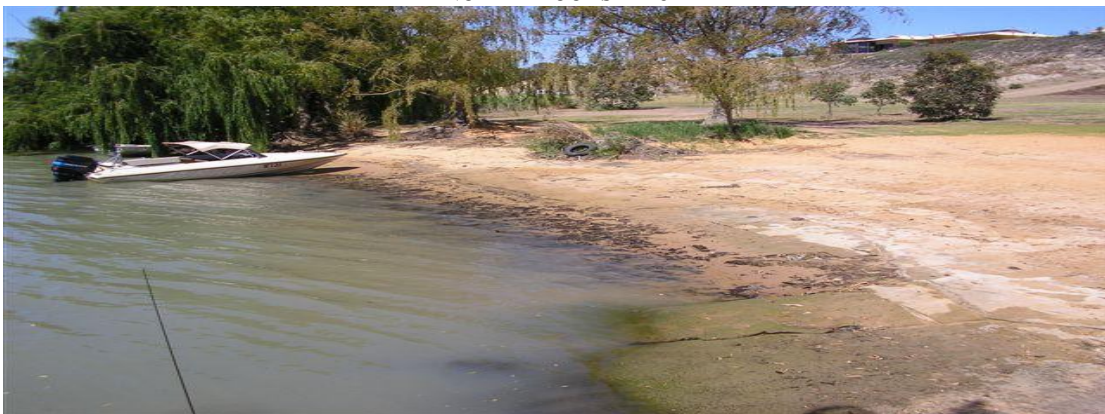
No 1 – Looks fine

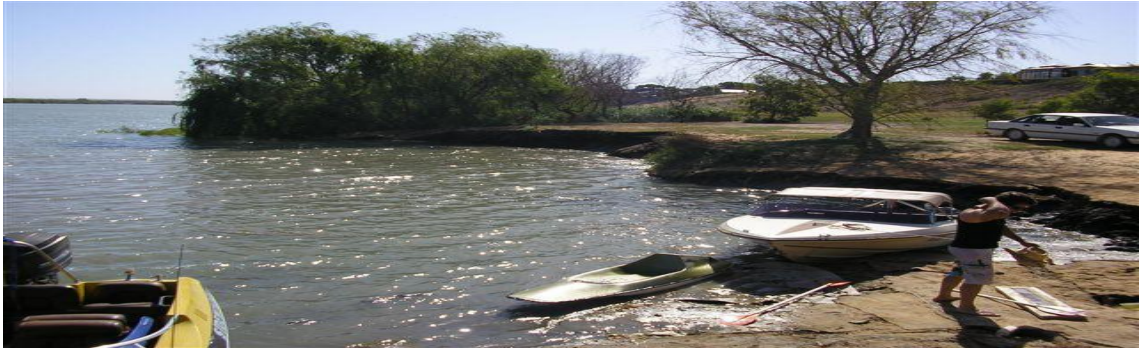
No 2 – After first collapse

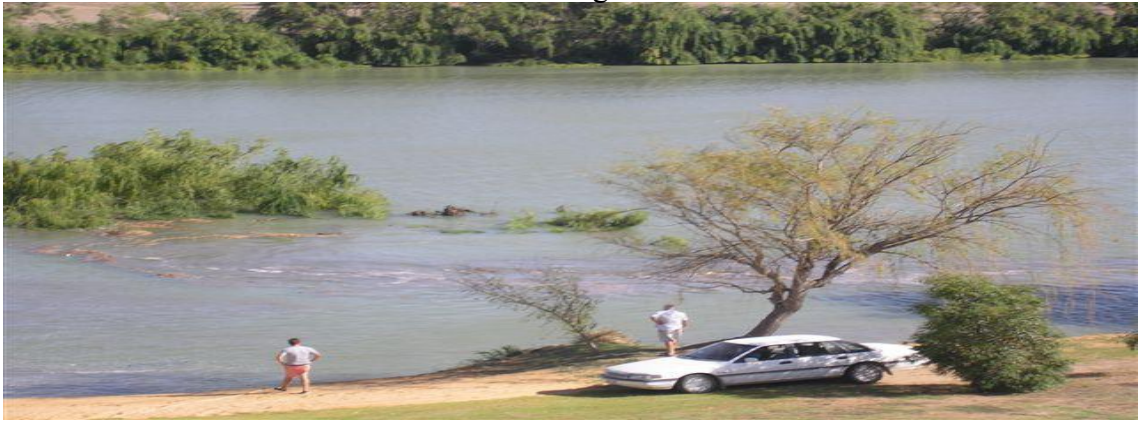
No 3 – Going further

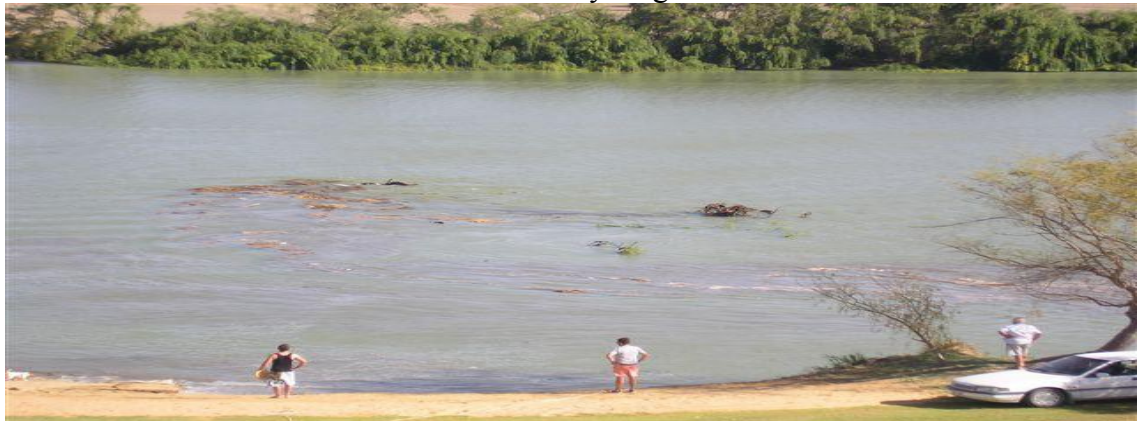
No 4 – Nearly all gone

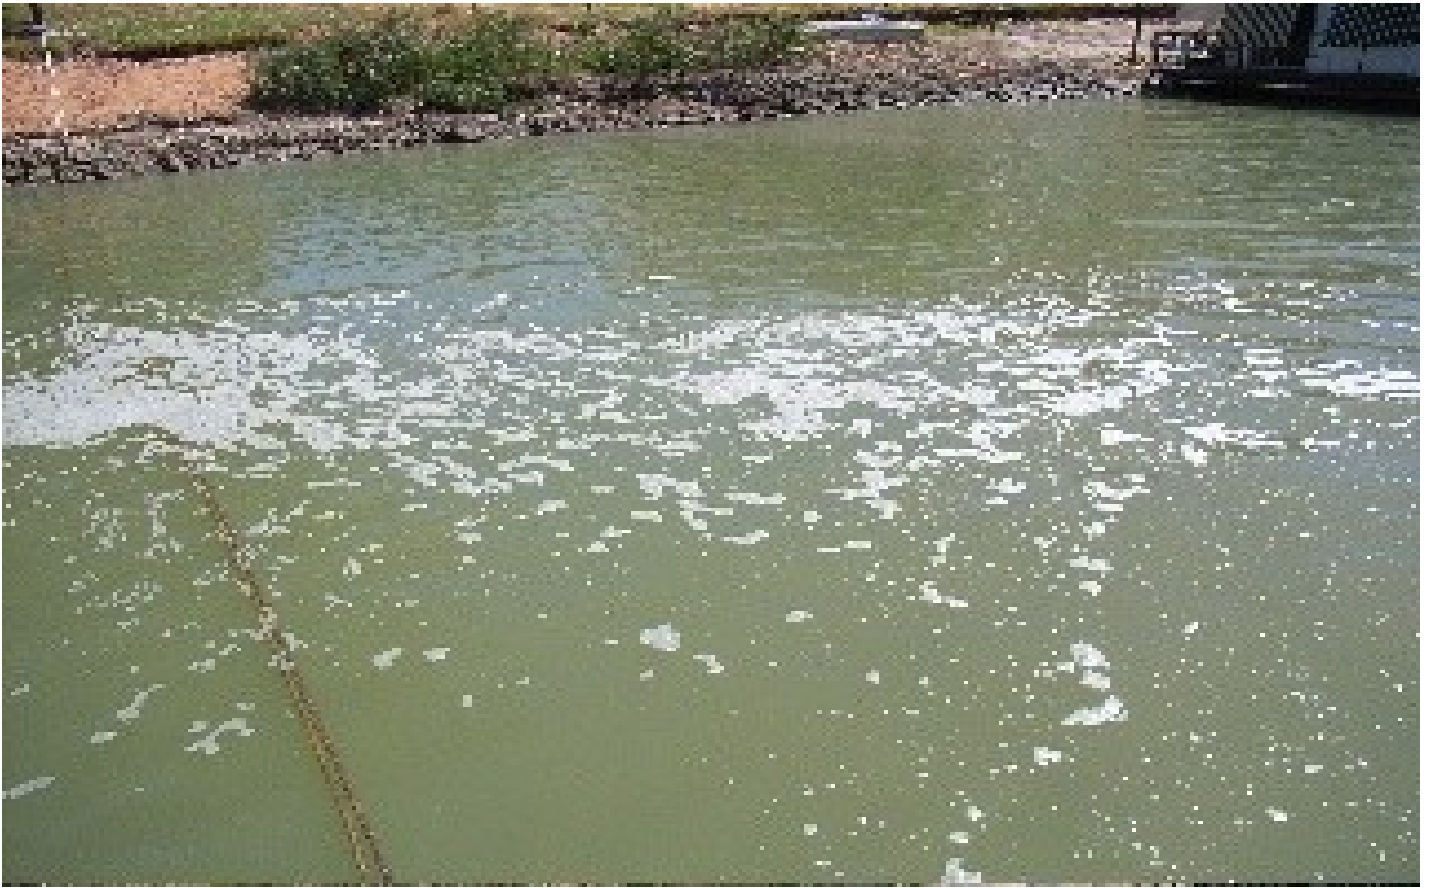
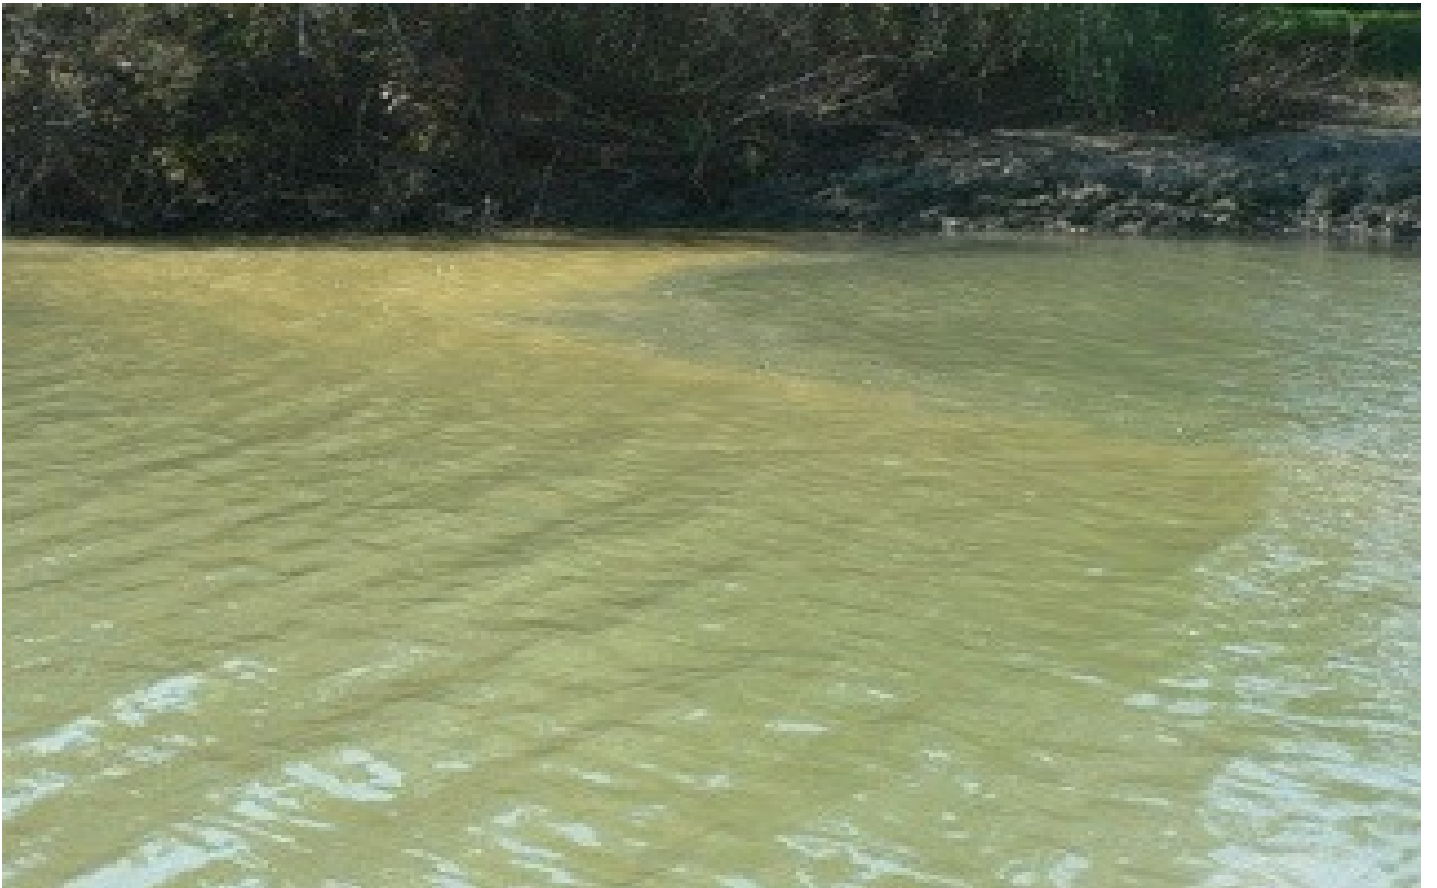
Signs of probable impending disaster

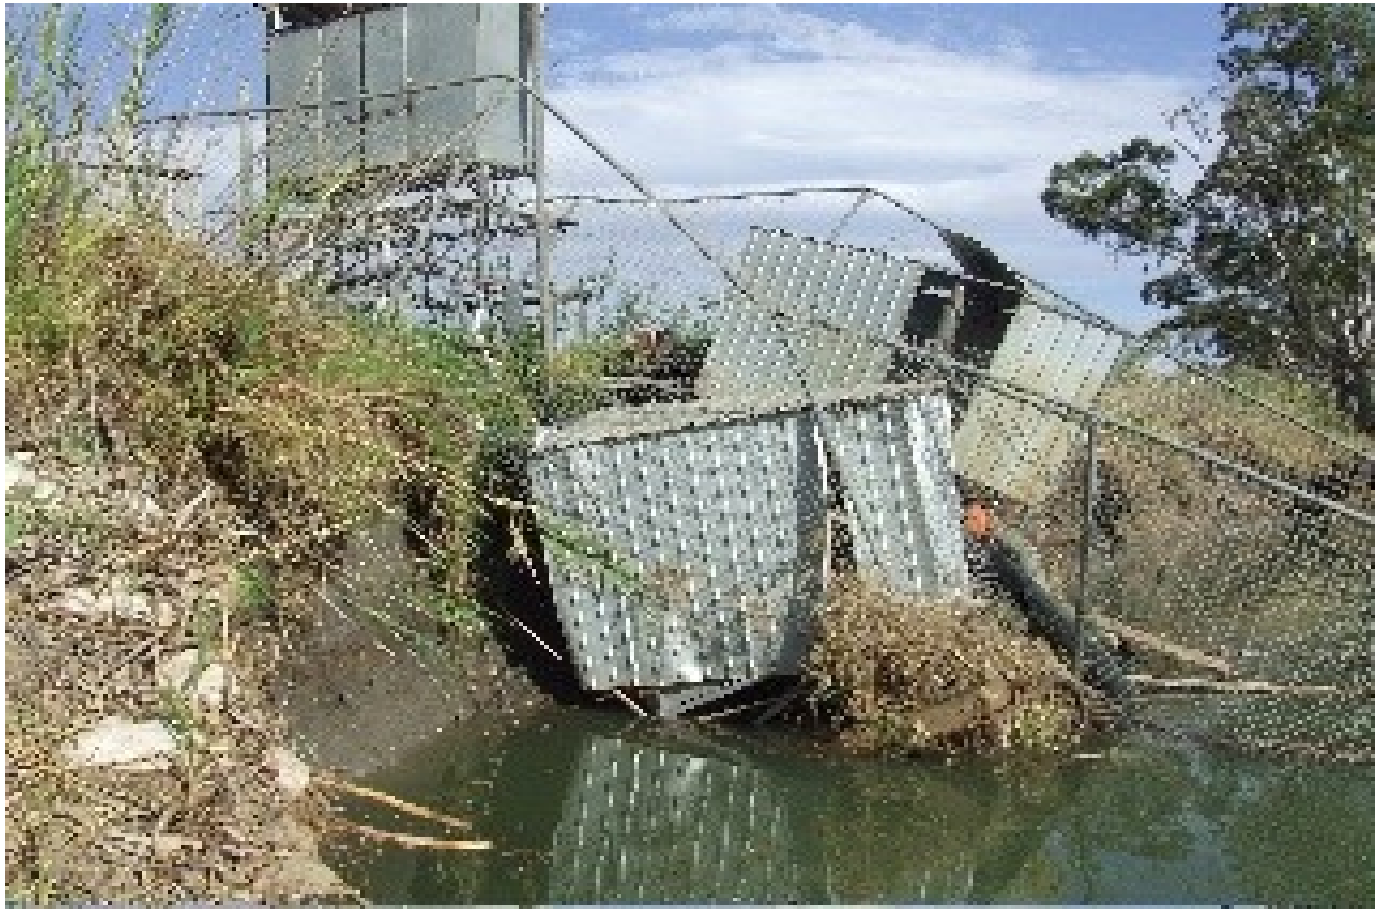
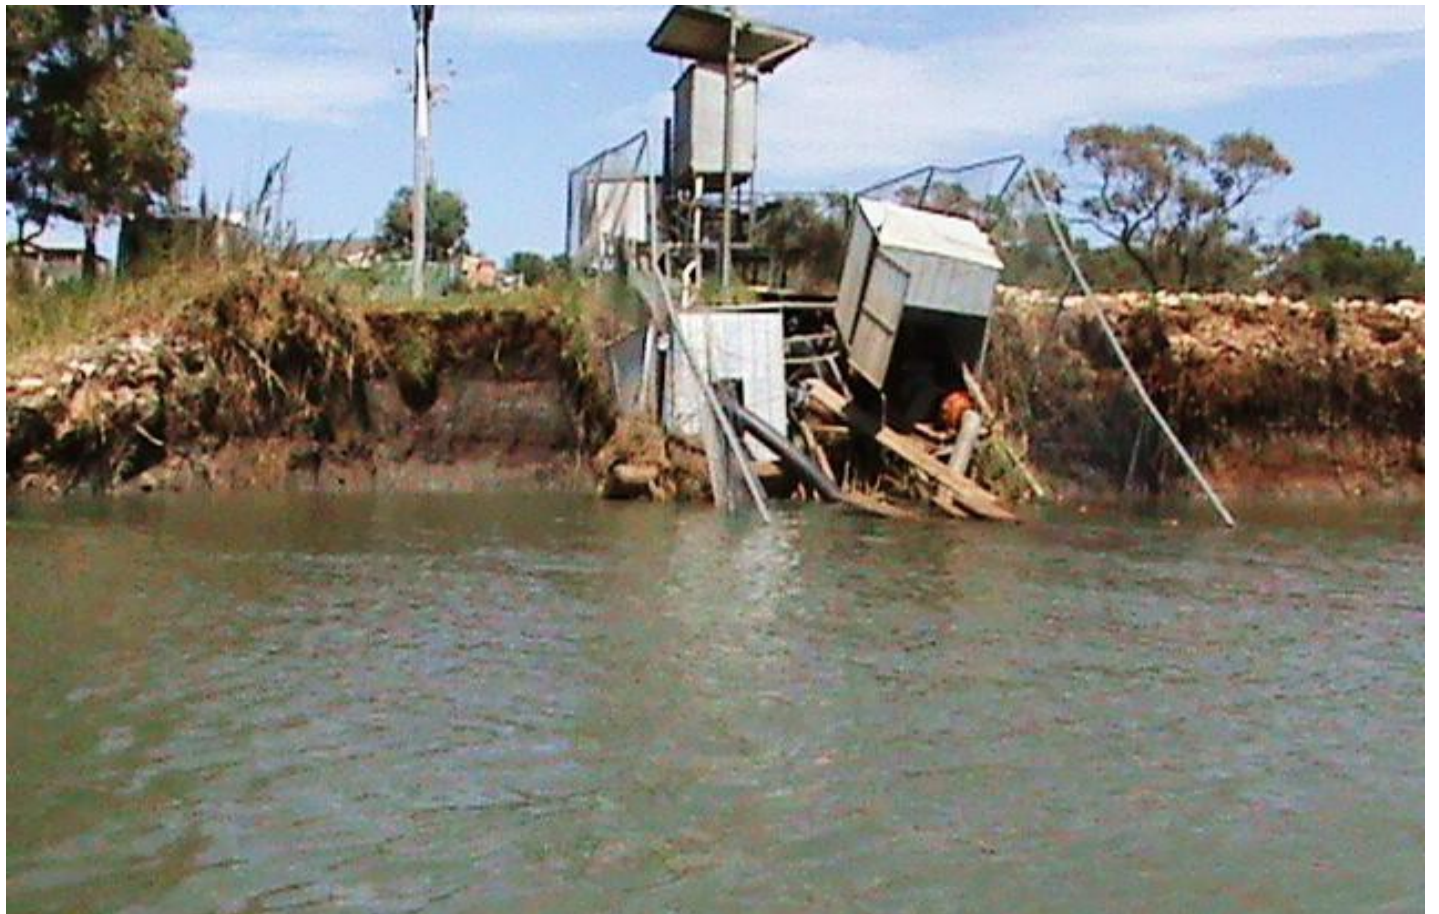
Damage to irrigation infrastructure

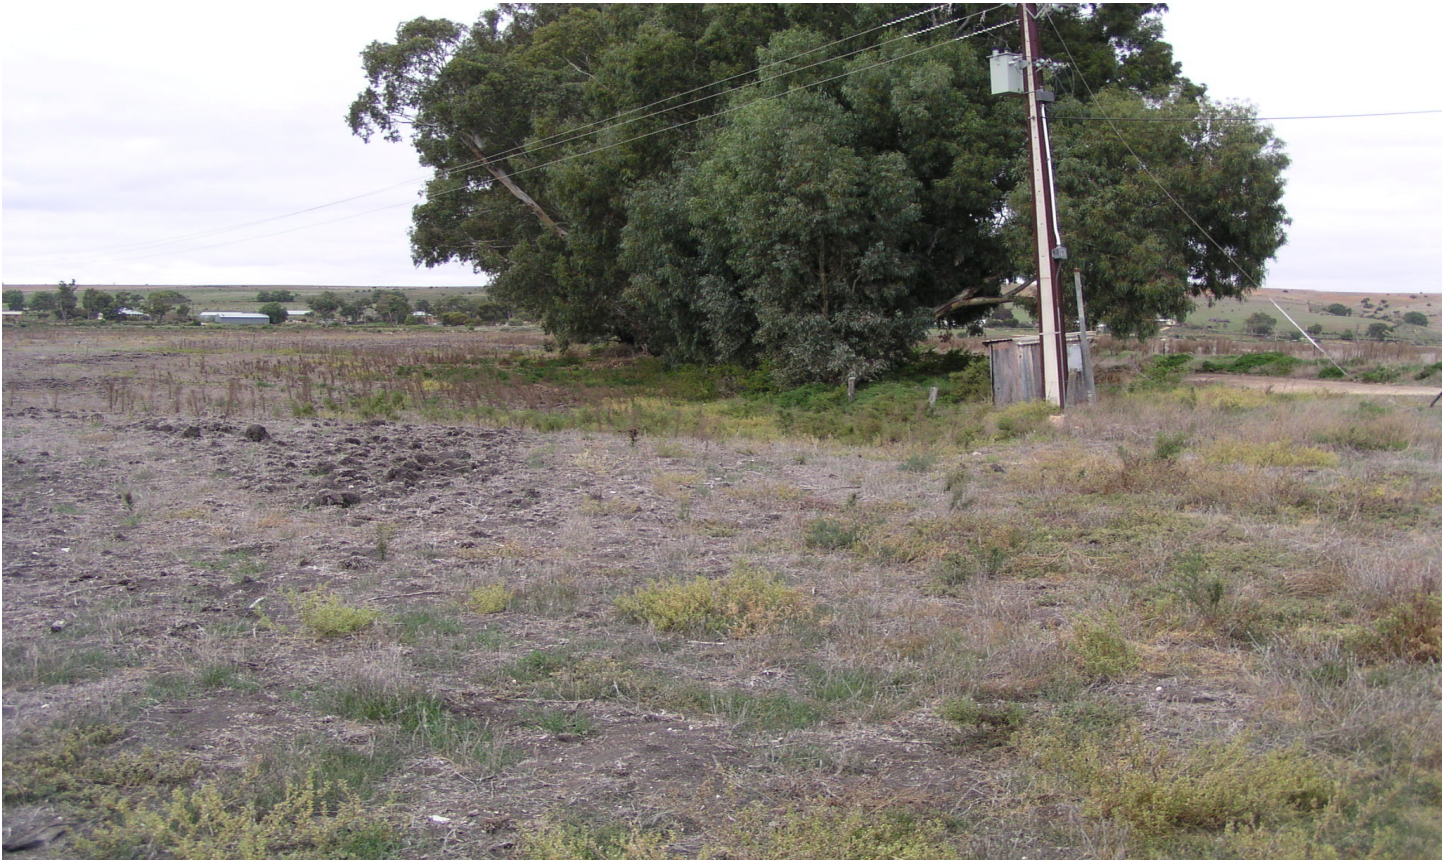
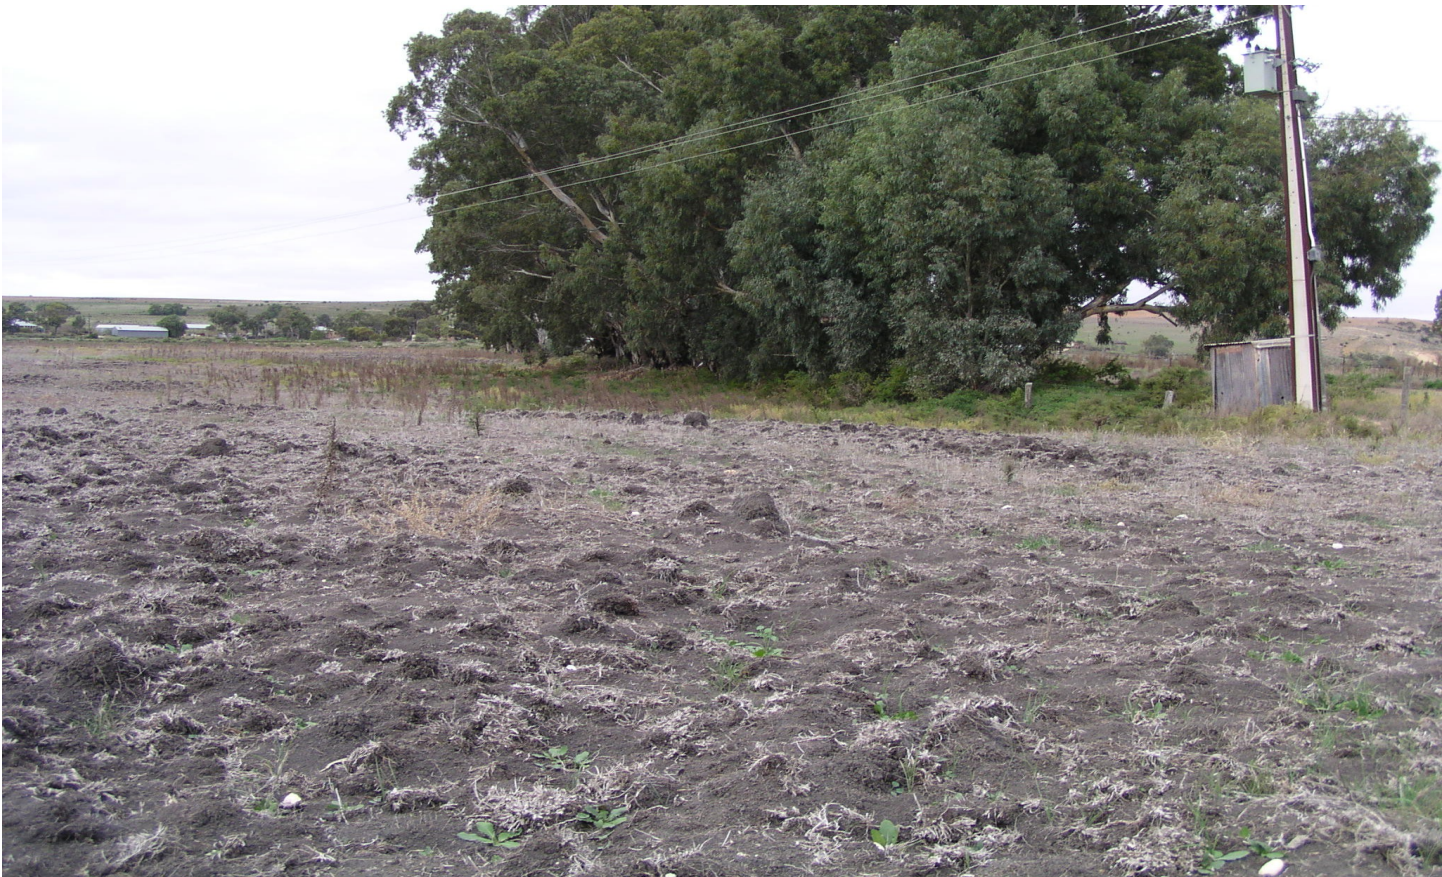
Stands of trees dropping

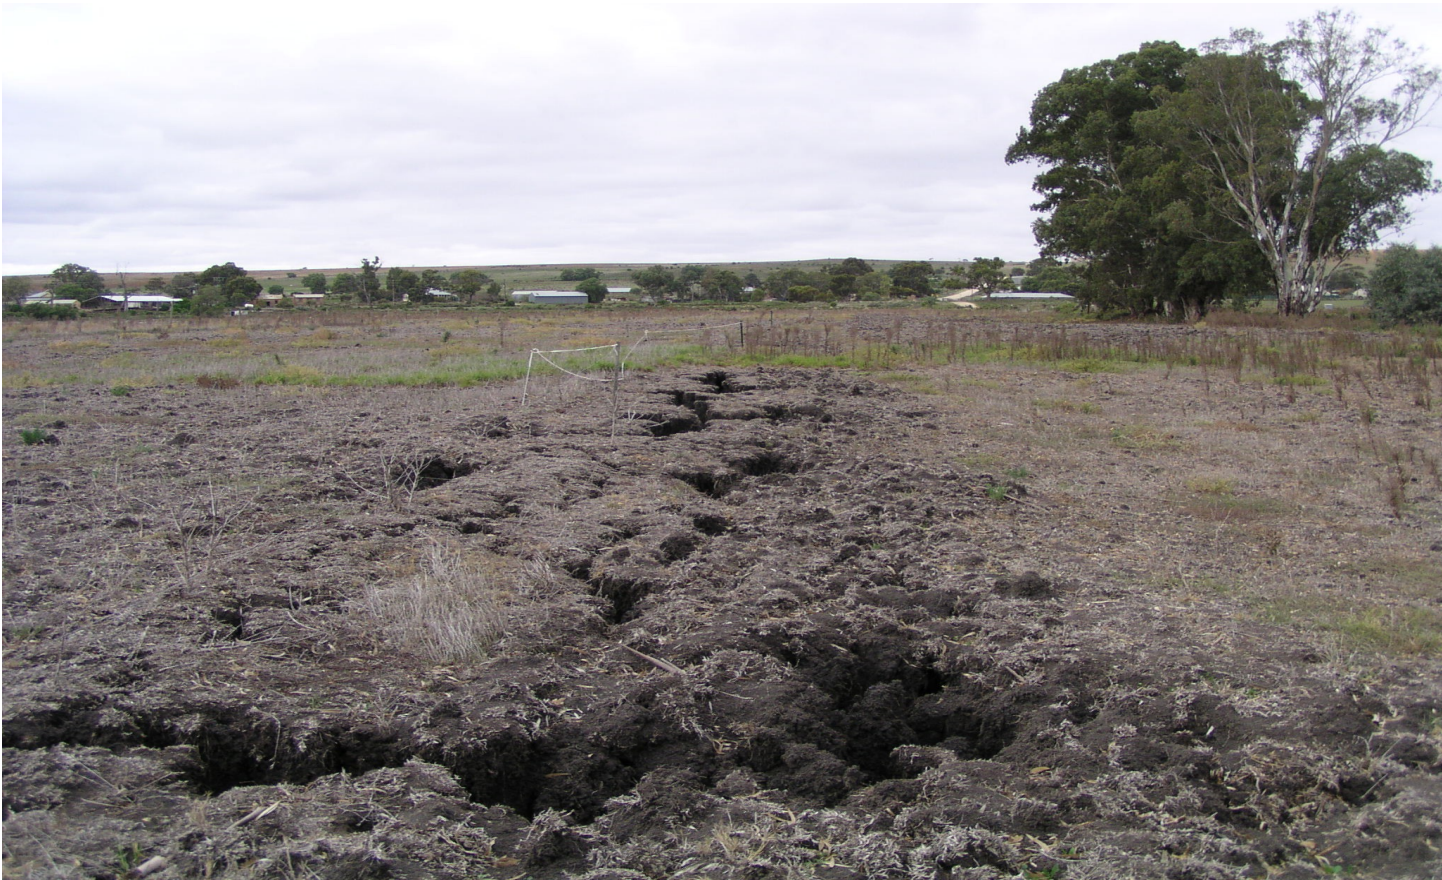
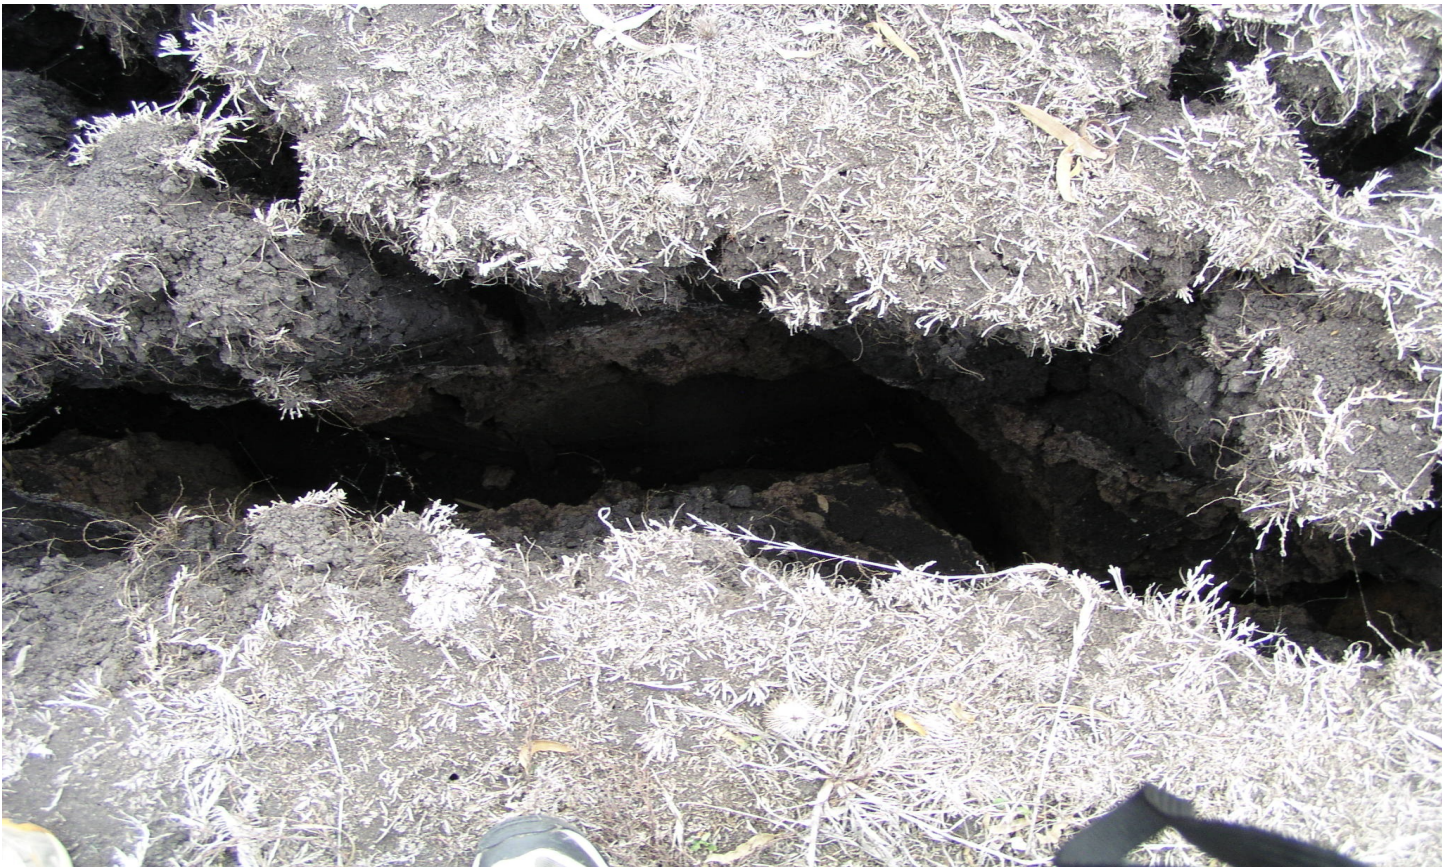
Large cracks in once laser levelled irrigation swamps

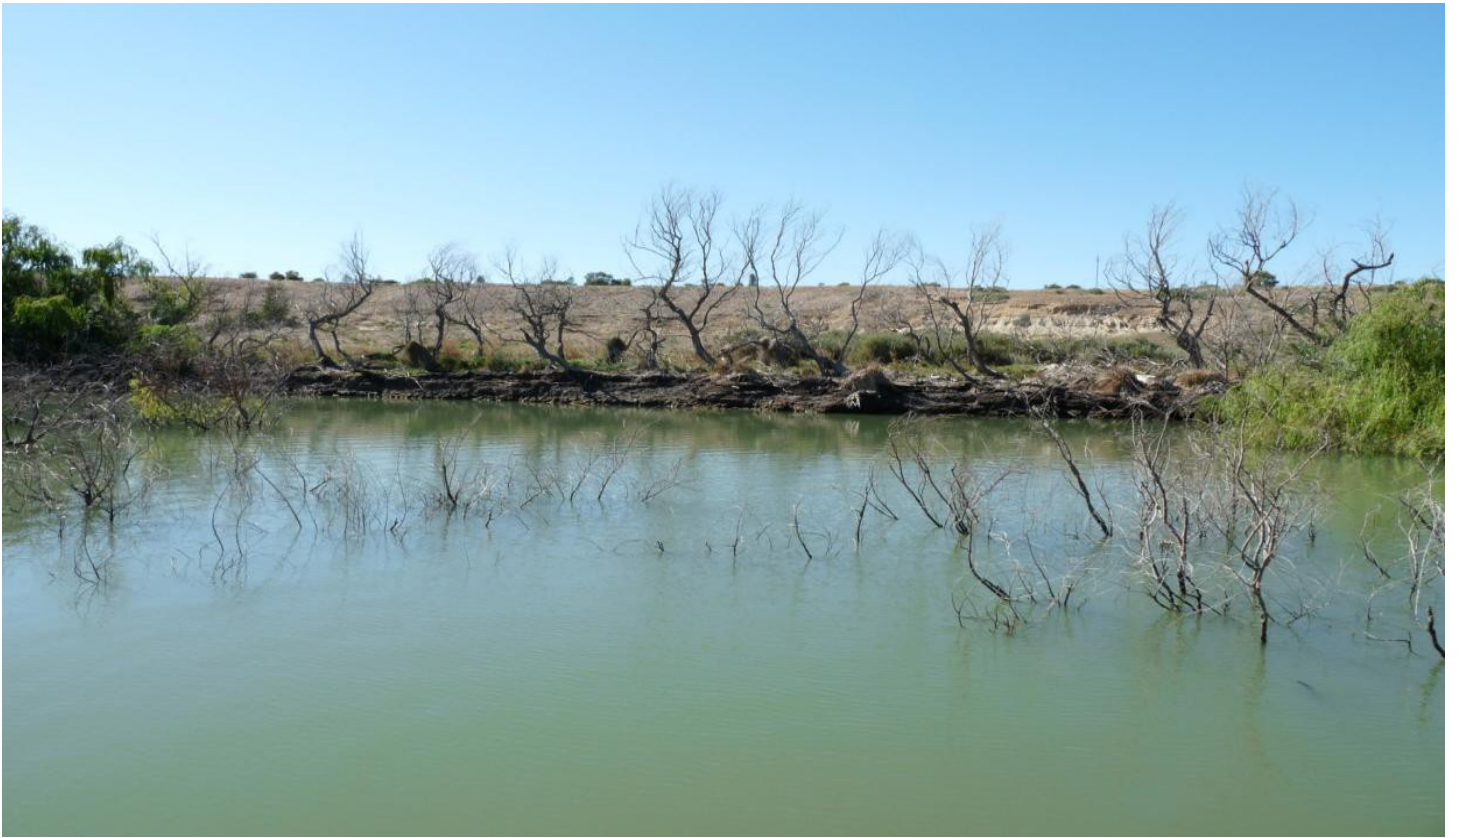
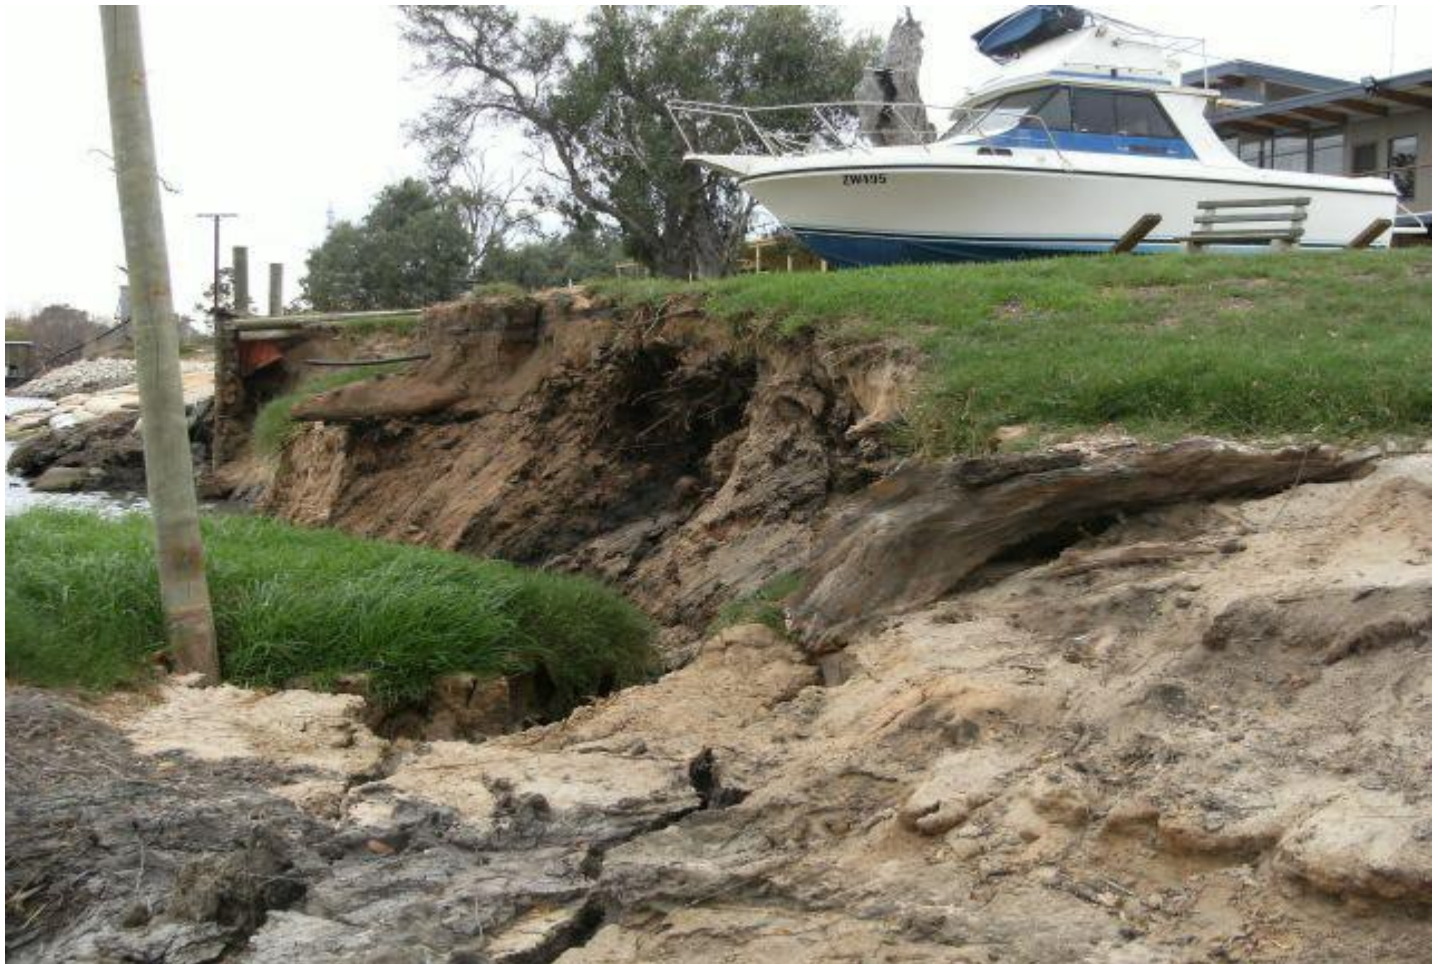
More bank collapse

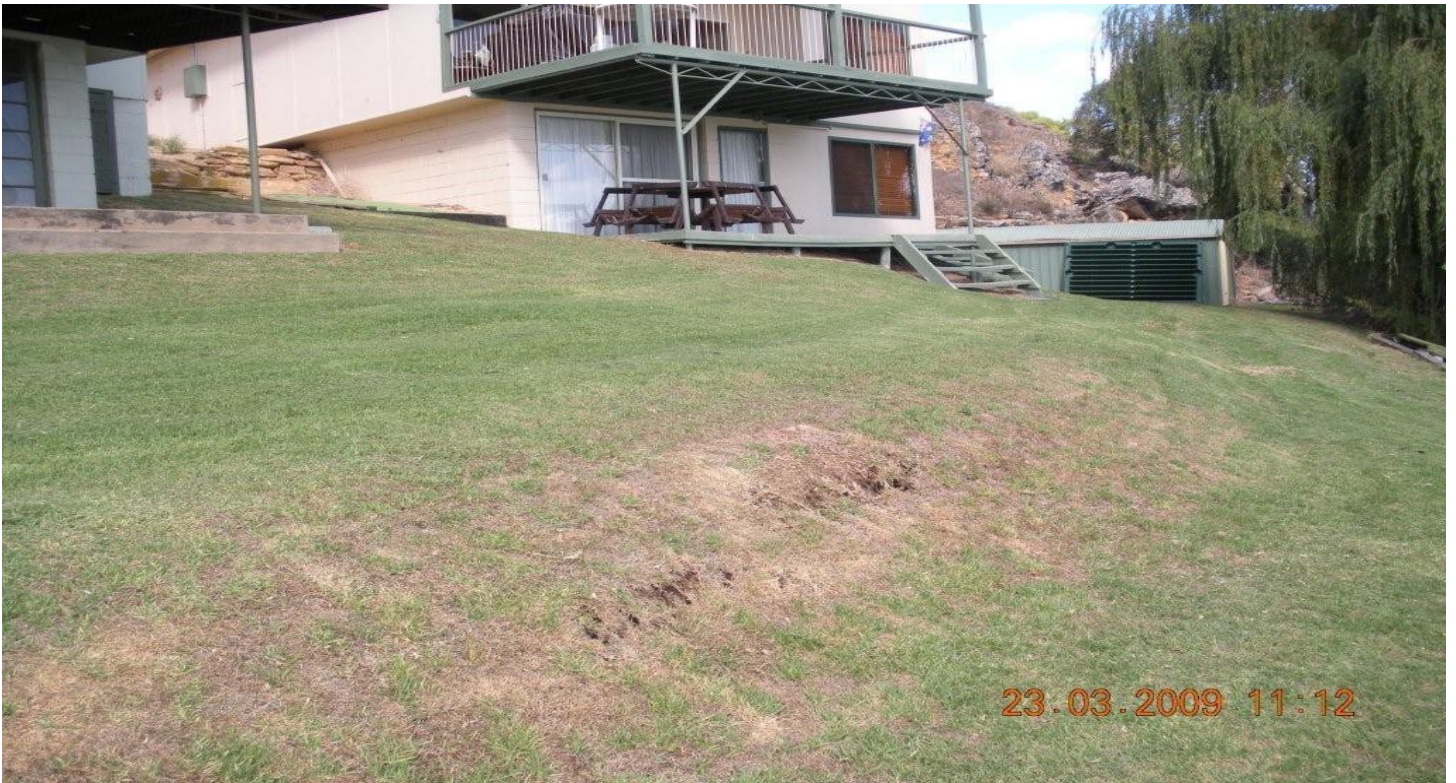
Cracks appearing away from the river

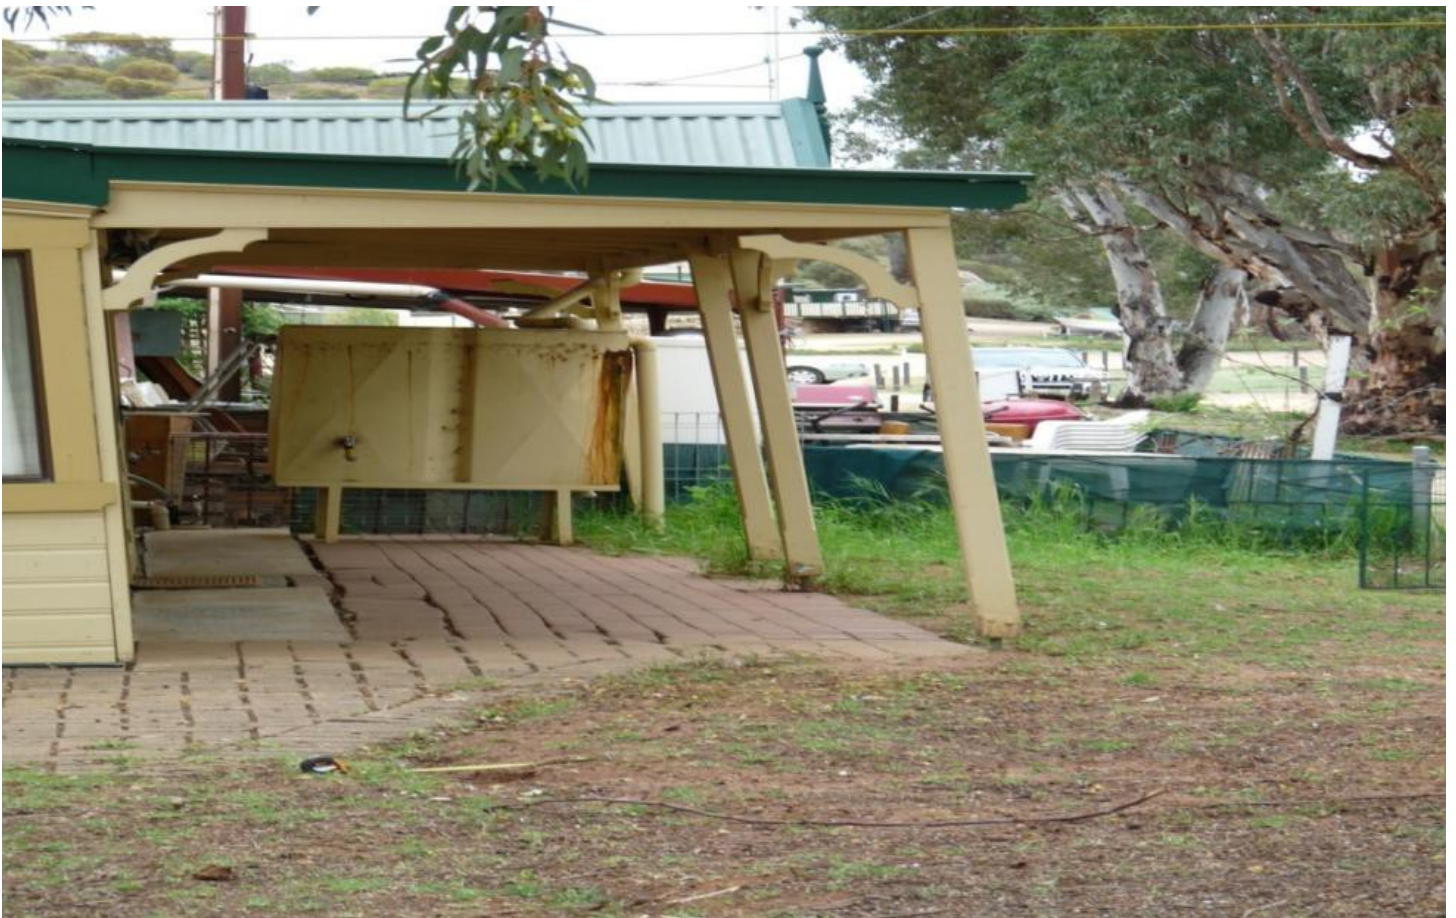
Damage caused by cracking and shifting soil

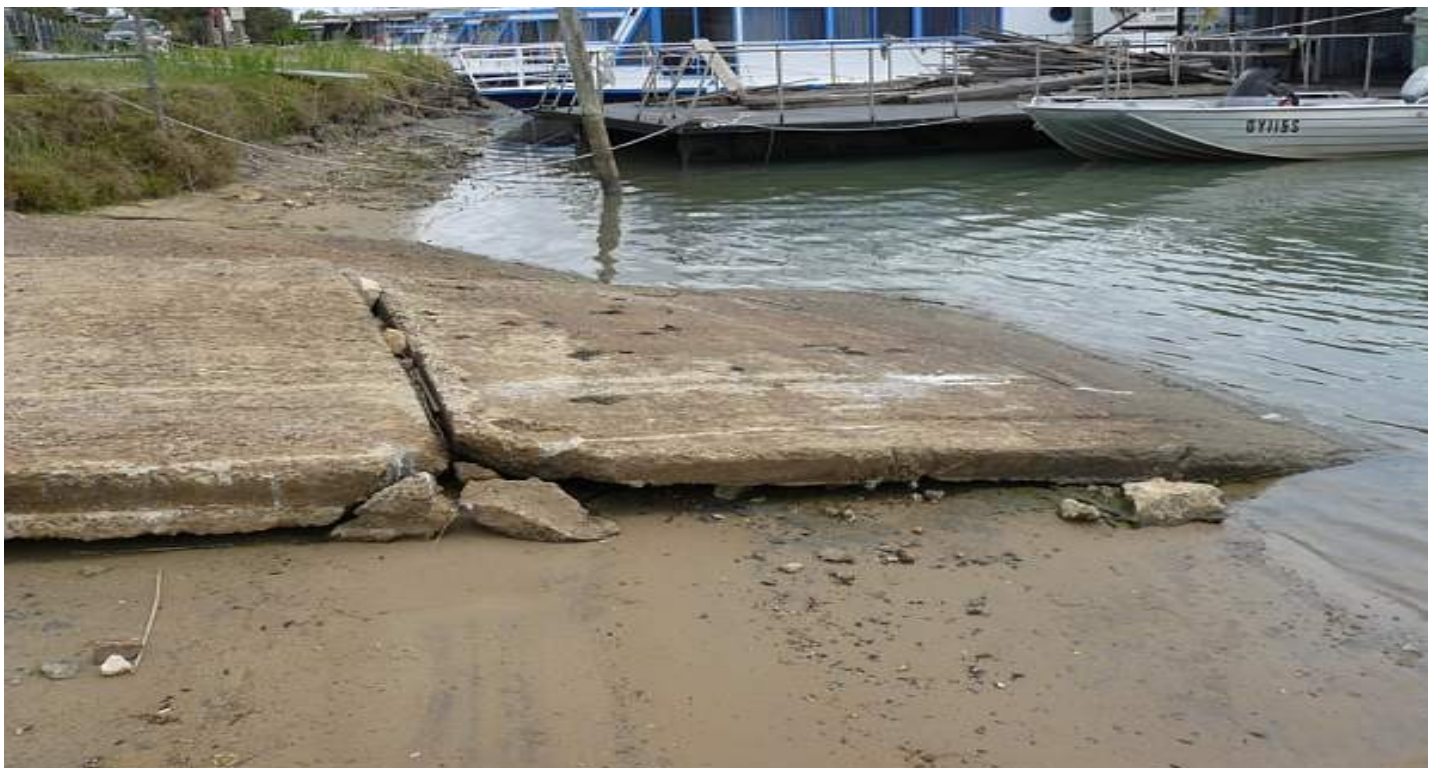
Problems with many boat ramps (one of the better ones) – Many have had to be closed

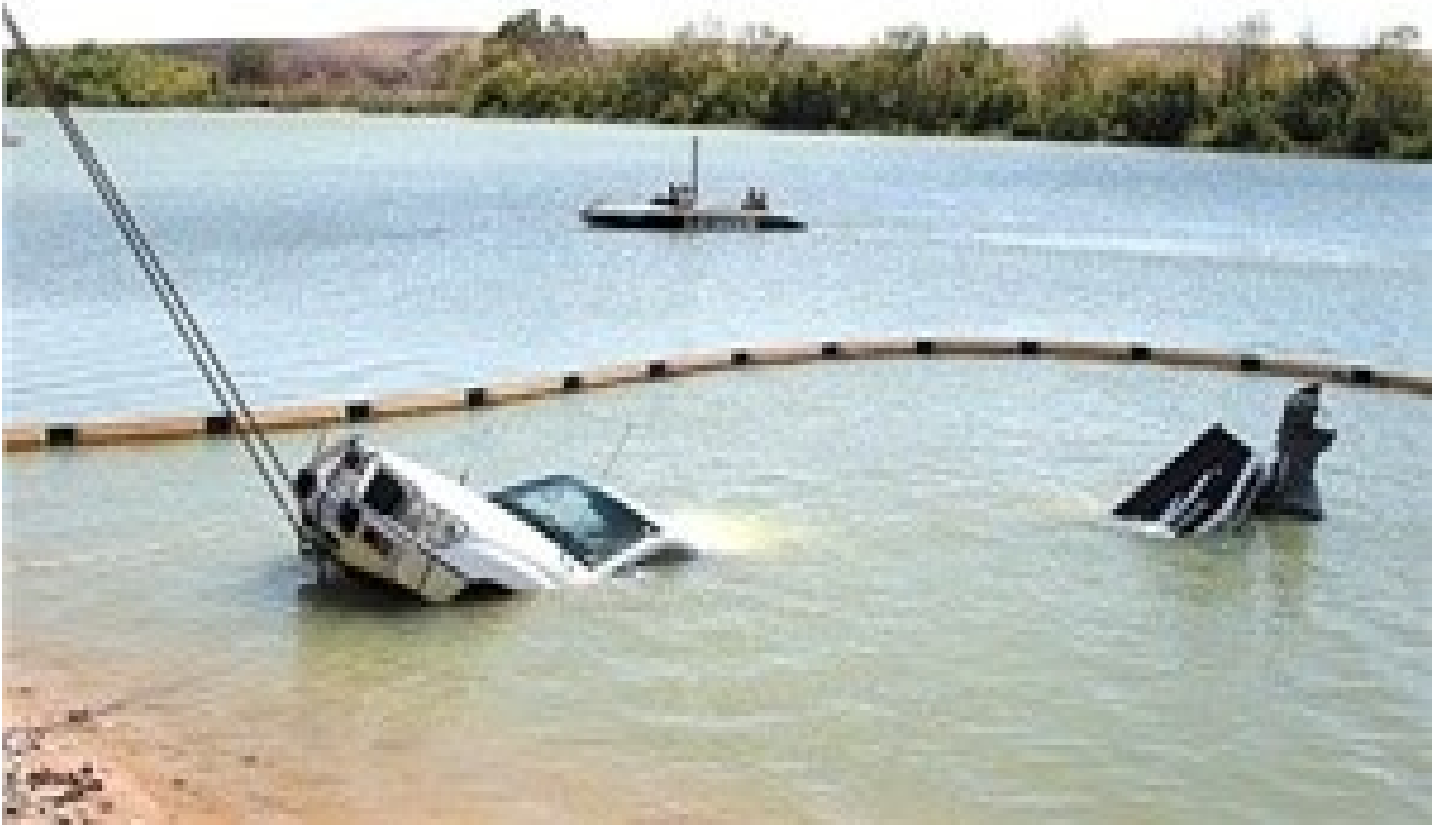
Swallowed: A Landcruiser and ski boat are pulled from the river at the Avoca Dell boat ramp, where the channel is barely a metre from the water's edge.

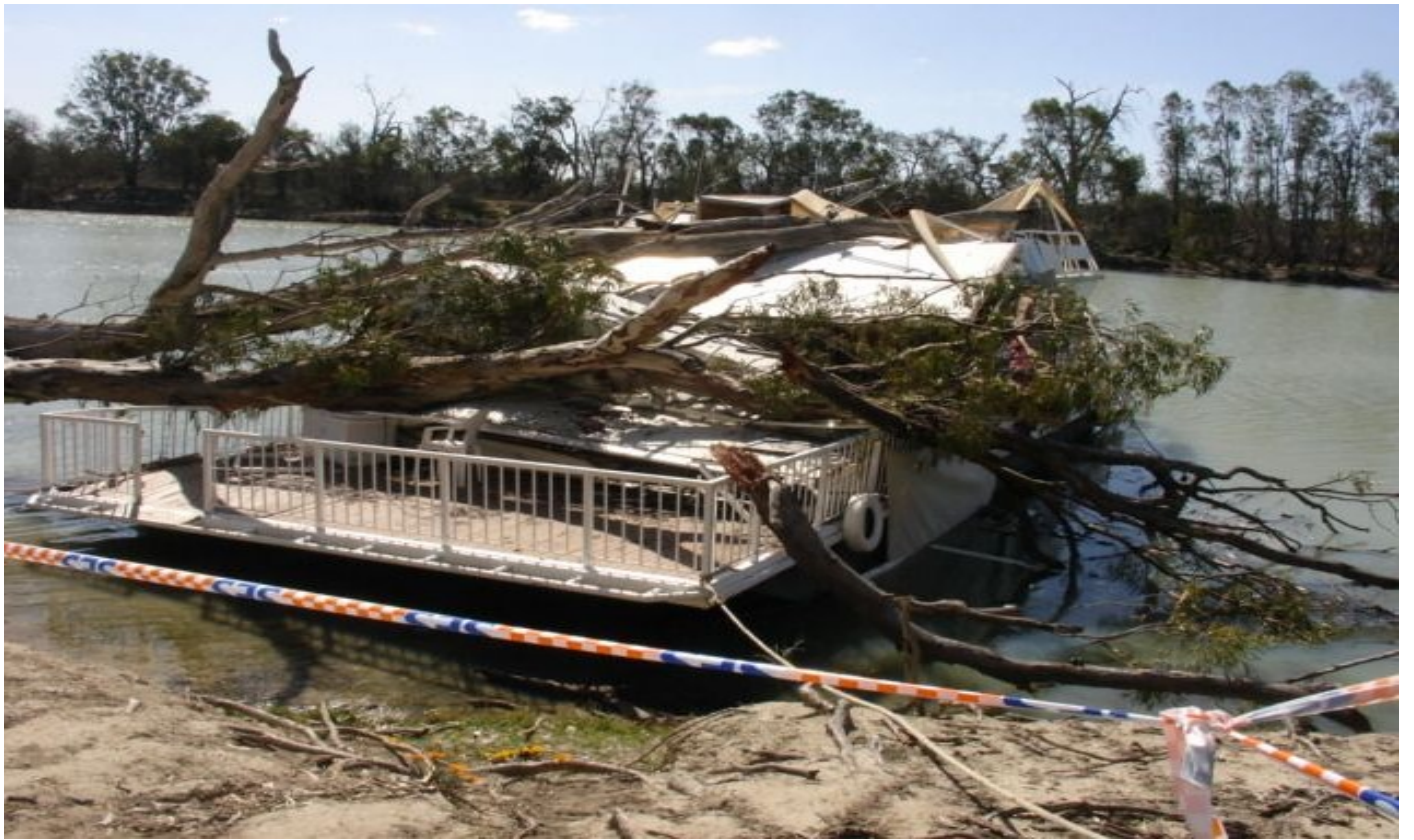
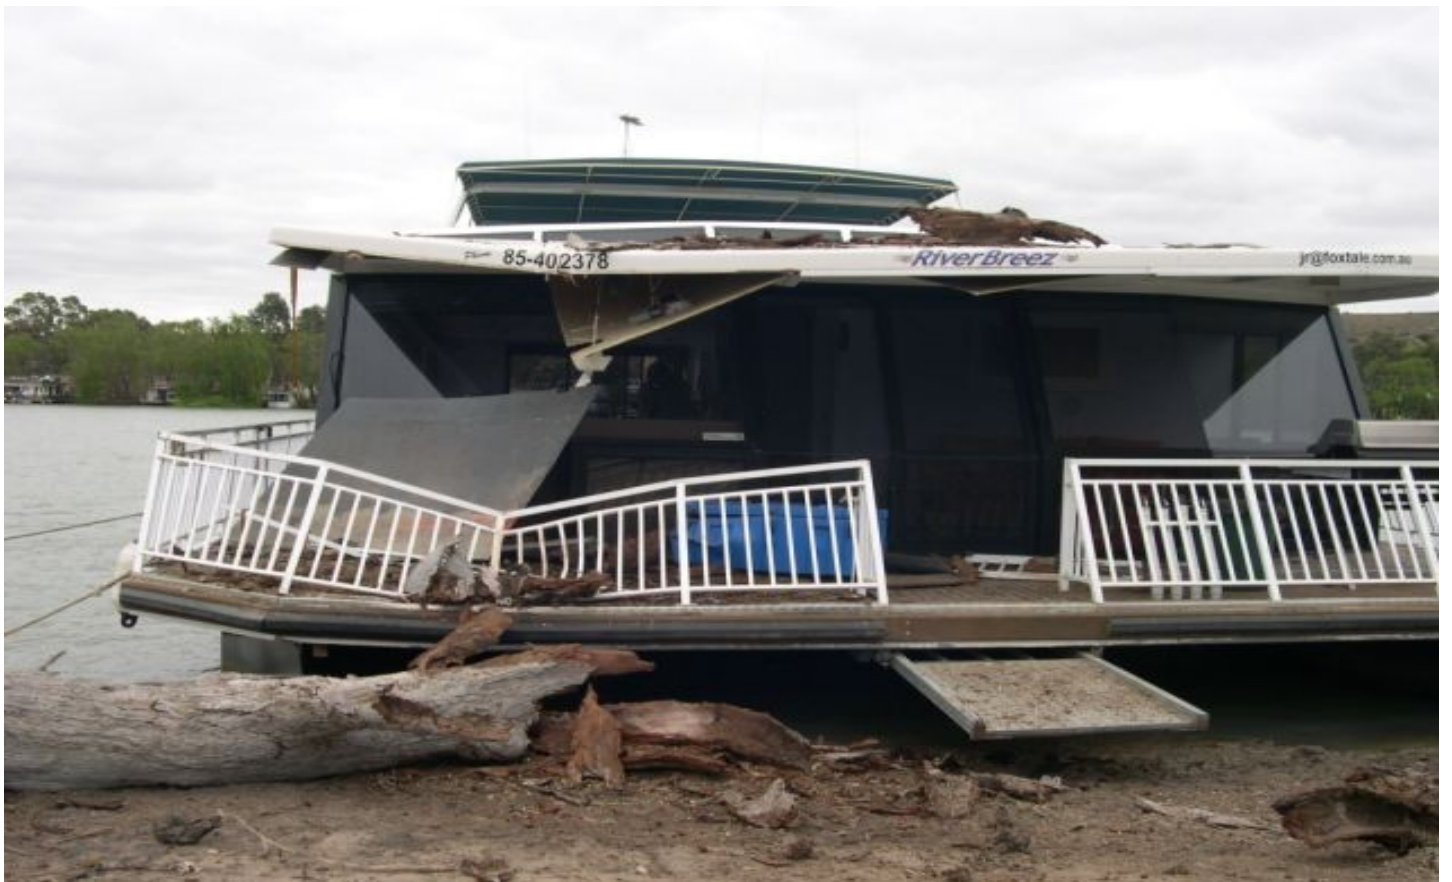
Houseboats damaged caused by shifting banks causing trees to fall

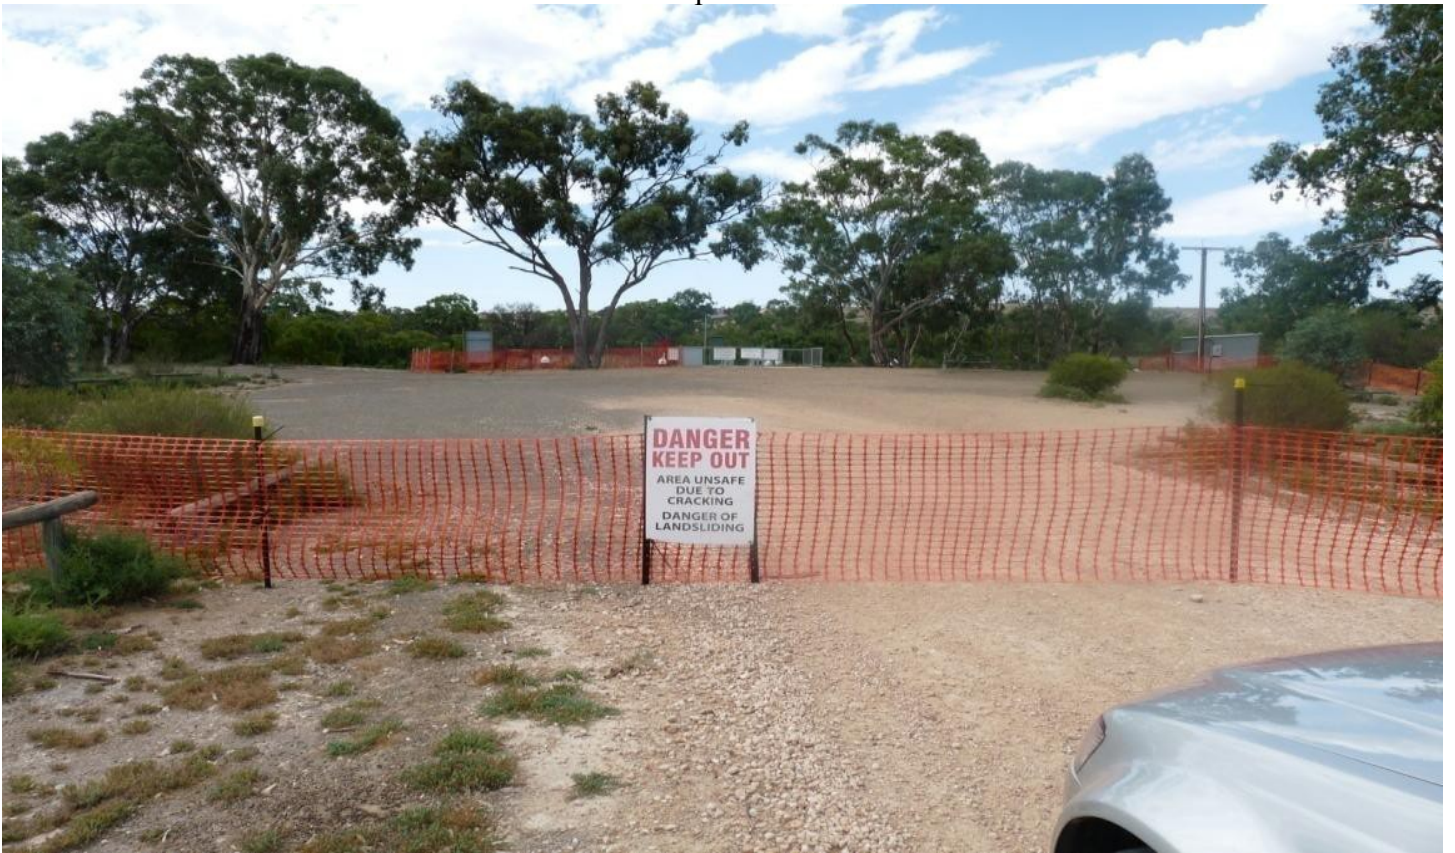
Road closers  
Walker Flat Pump Out Station closed.
