**Visual evidence of the massive problems associated with total mis-management of the Murray Darling Basin by consecutive Federal, State and Local Governments.**

Long Island Marina – Murray Bridge – South Australia

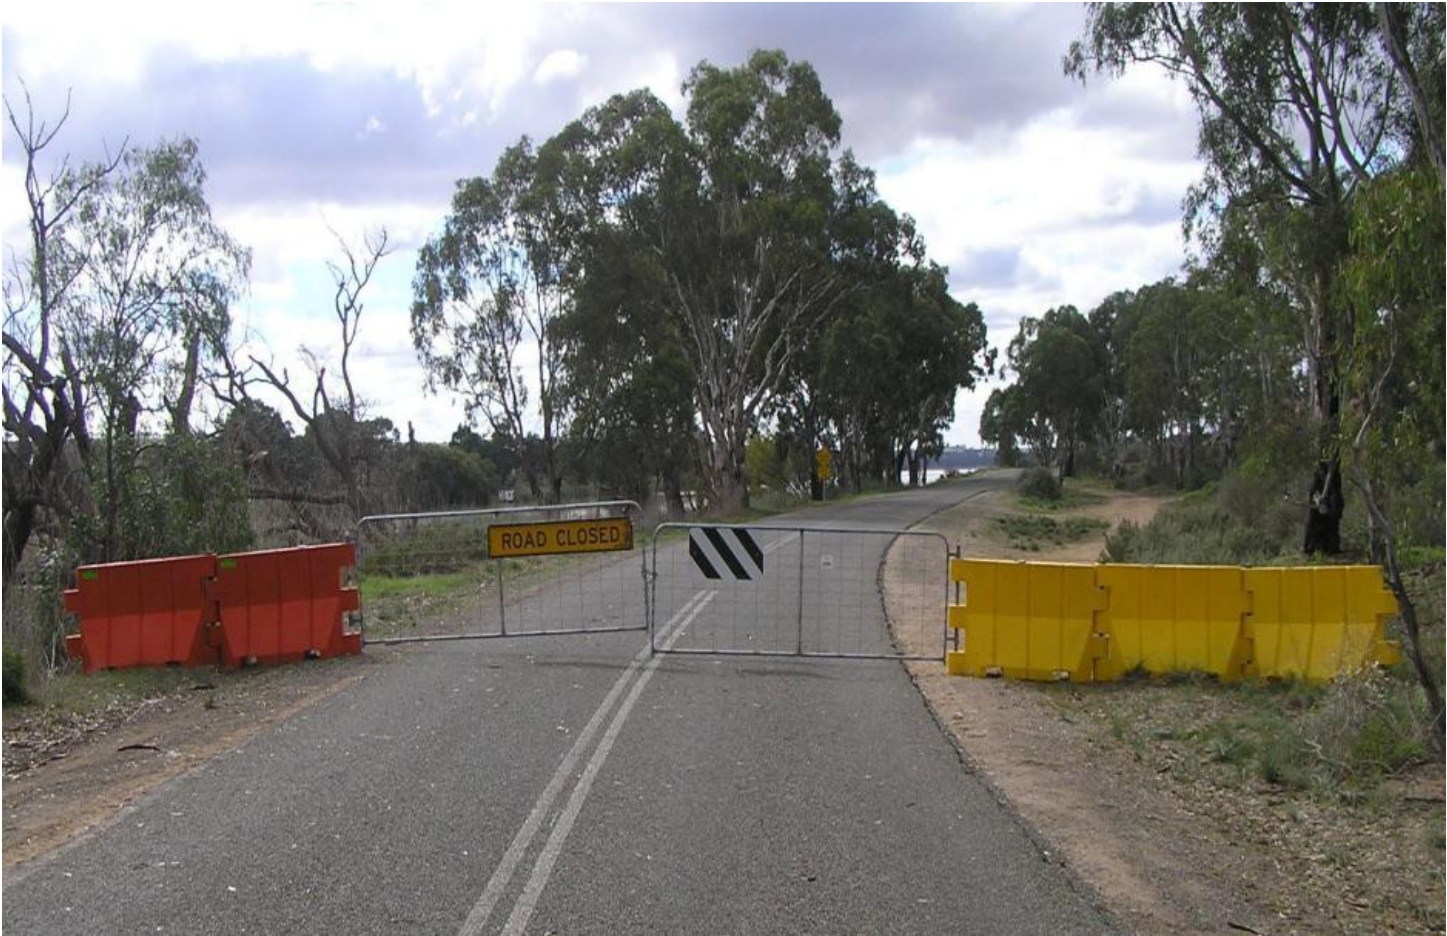
East Front Road has been closed – SAPOL order

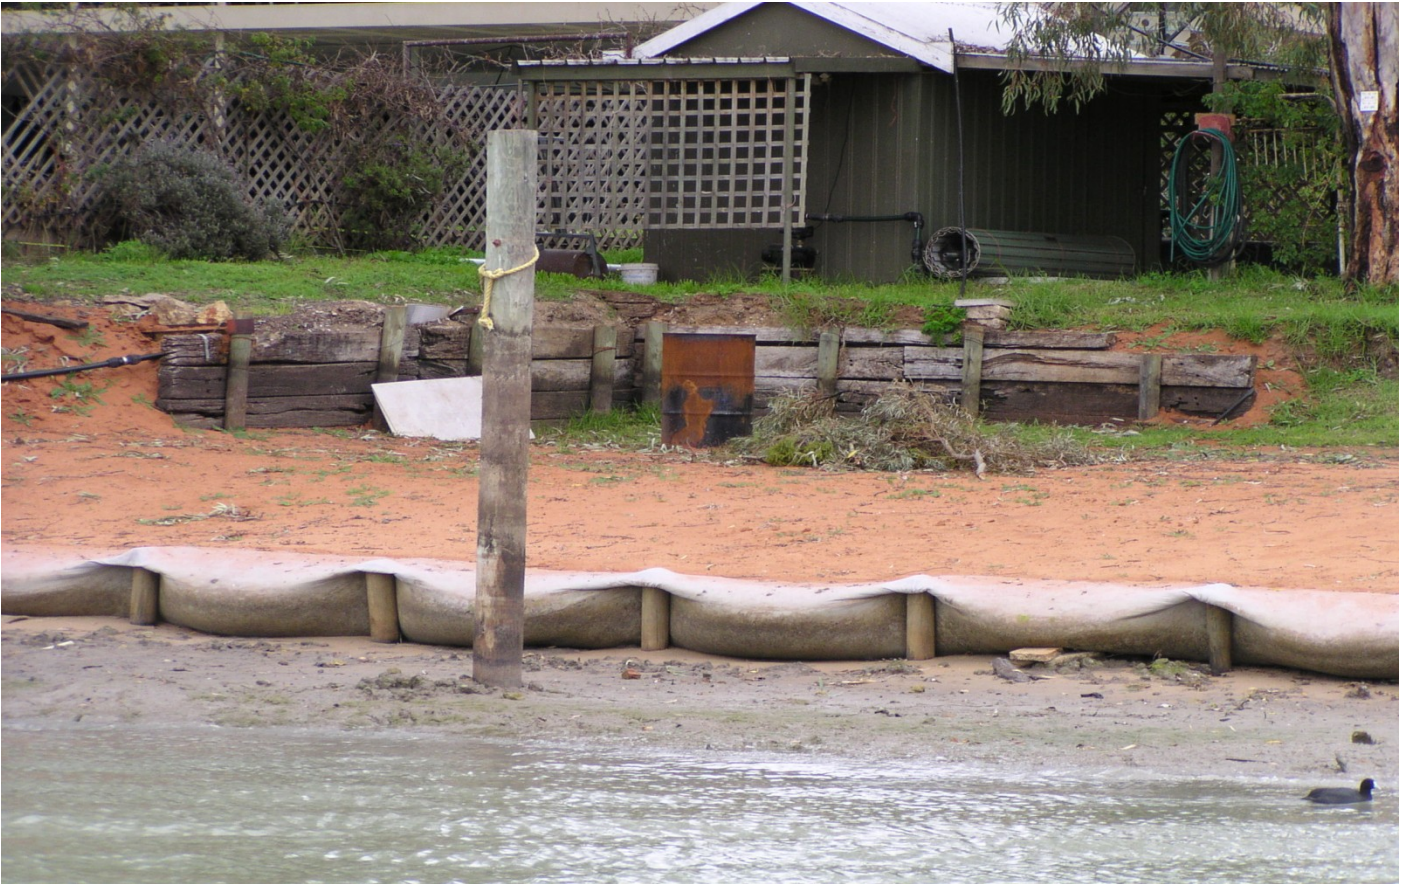
Illegal developments (below Pool Level) are springing up along the River

The original river's edge when the property was purchased was the sleepers on the right hand side the new owners removed the sleepers that were a houseboat mooring, the permapine post was the rear tie up post for the rear of the houseboats. The sand bank wall at the front and the posts are nearly 32 feet out into the river from the original river boundary.

Development below Pool Level is illegal.

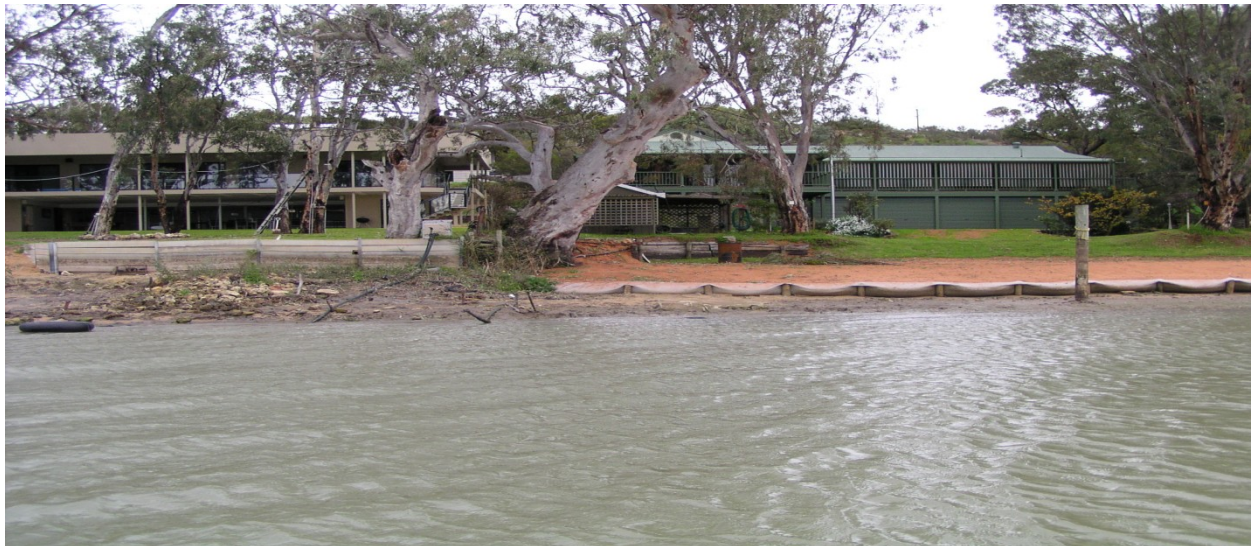
Both of the below properties have carried out alterations below Pool Level

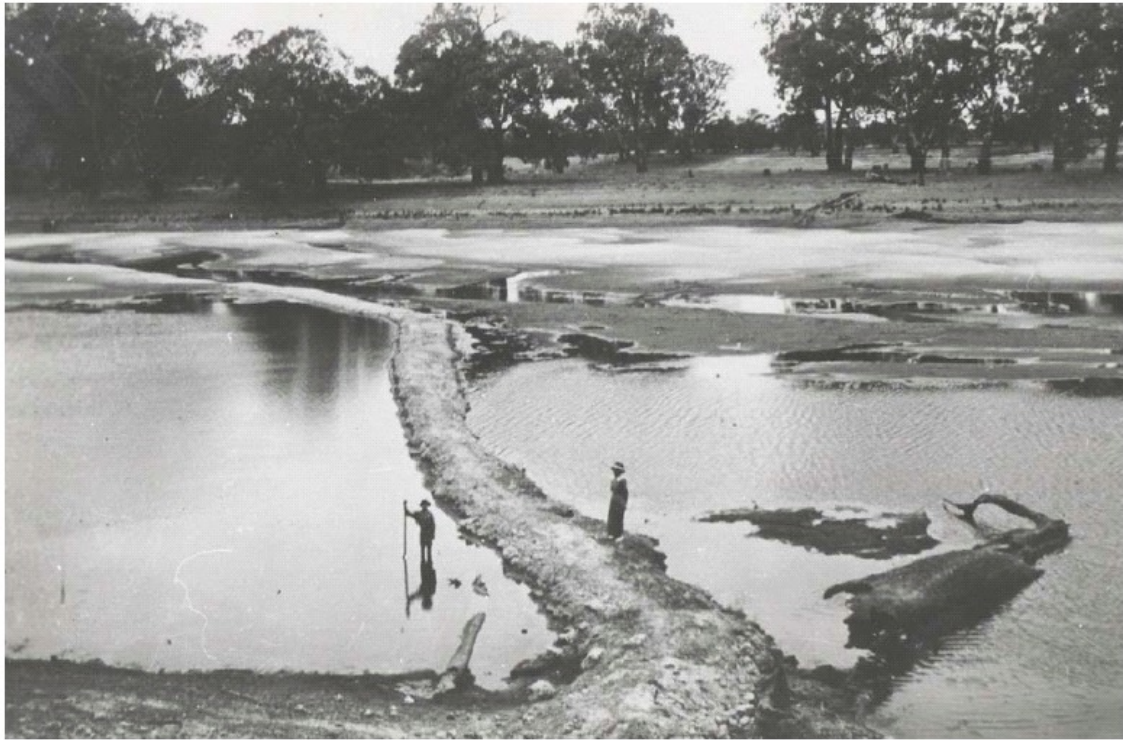
Figure 3. Murray River at Wentworth, NSW during the 1914 drought. (Photo courtesy of the State Library of South Australia)
